Asbestos and Lead-Based Paint Inspection

3760 & 3678 Park Avenue
Doraville, DeKalb County, Georgia

May 2018

Prepared for:
City of Doraville Downtown Development Authority
EPA Cooperative Agreement BF-00D48116-0

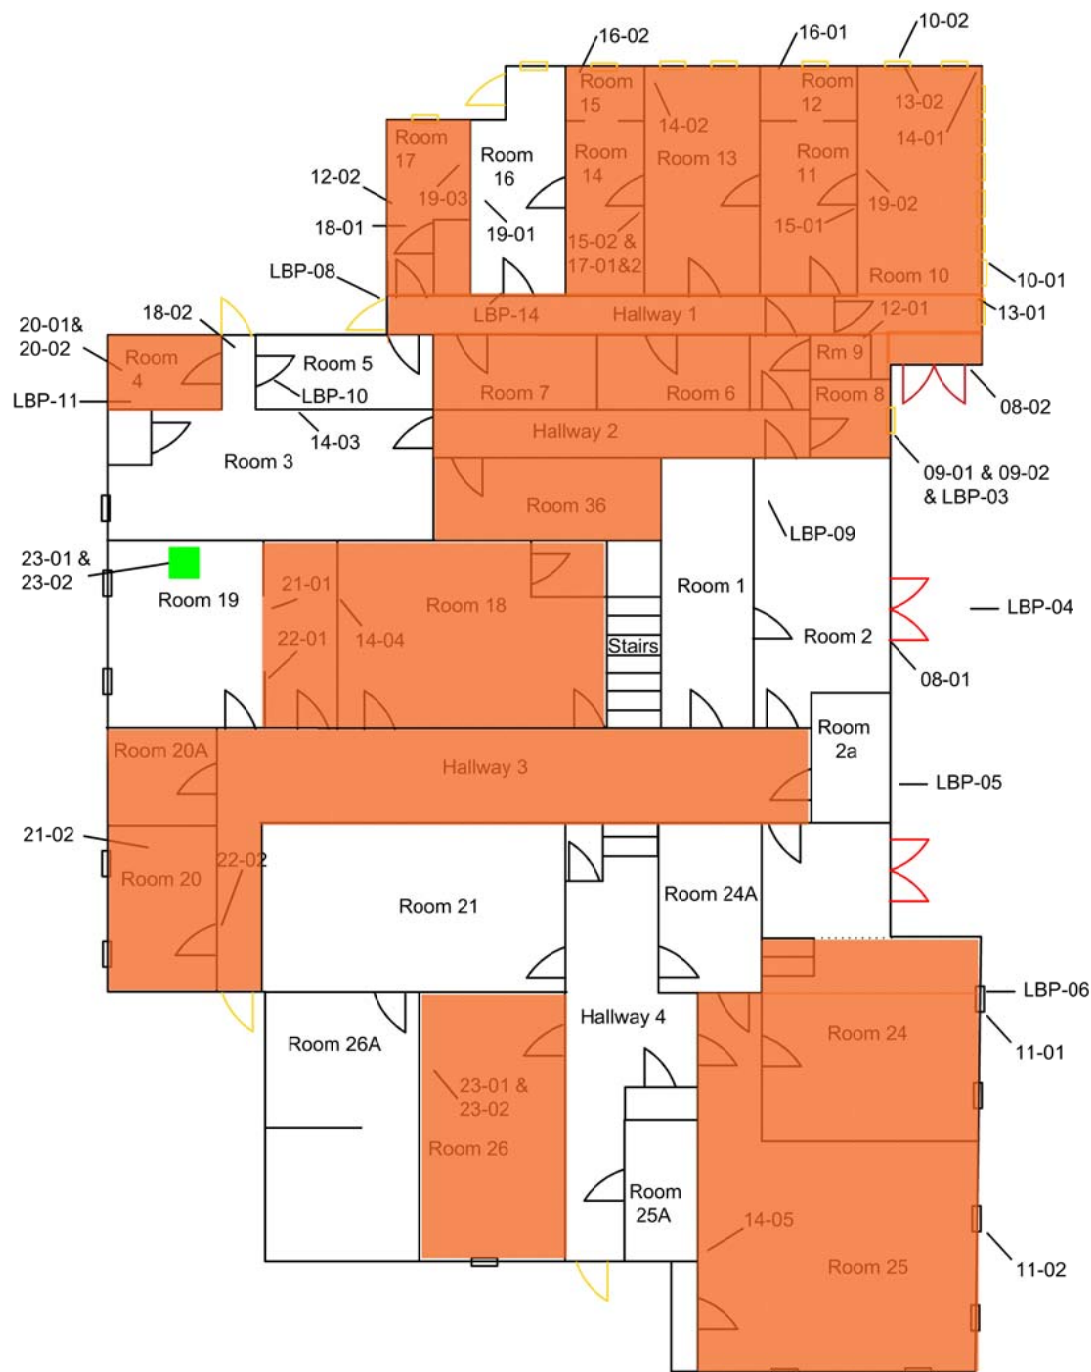
**Figure 6c - 3760 Park Avenue, 1st Floor
Asbestos and Lead-Based Paint Sample
and Material Location Map**

Key	
01-01 - Asbestos Sample Location	
LBP-01 - Lead-Based Paint Sample Location	
	- Confirmed ACM Floor tile and mastic
	- Confirmed ACM door caulking
	- Confirmed ACM sink undercoating
	- Confirmed LBP
*Roof samples and materials not depicted

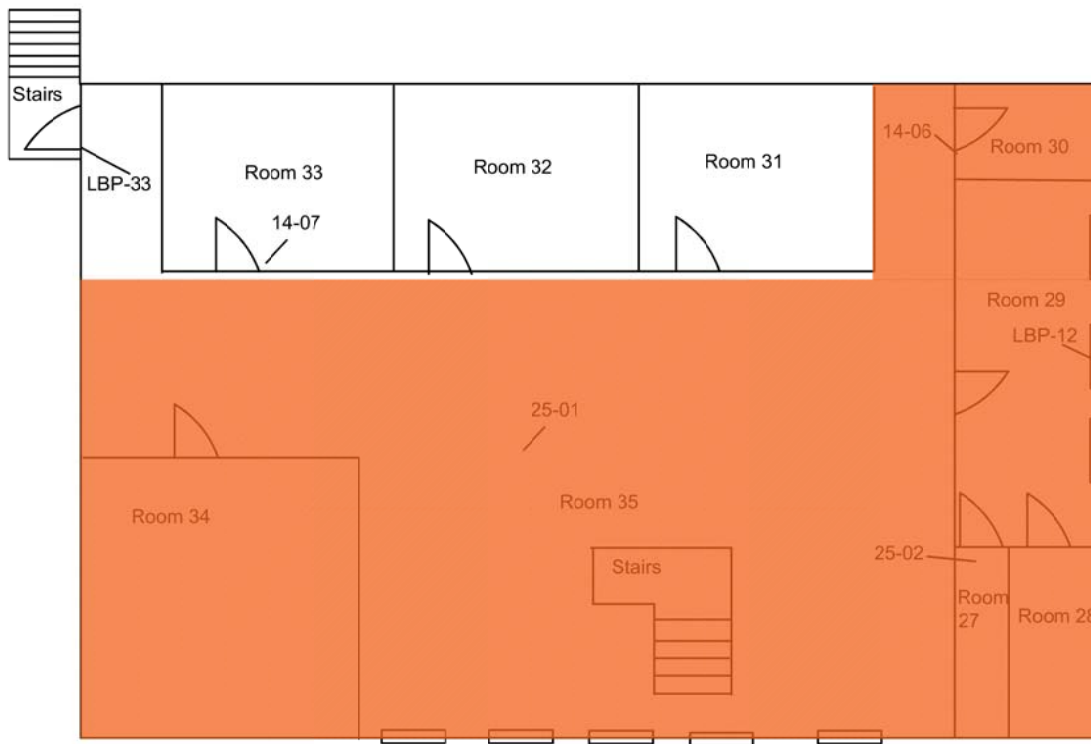
**Figure 6c - 3760 Park Avenue, 2nd Floor
Asbestos and Lead-Based Paint Sample
and Material Location Map**

*Roof samples not depicted
